Hindawi Publishing Corporation Case Reports in Dentistry Volume 2016, Article ID 9728593, 7 pages http://dx.doi.org/10.1155/2016/9728593

Case Report

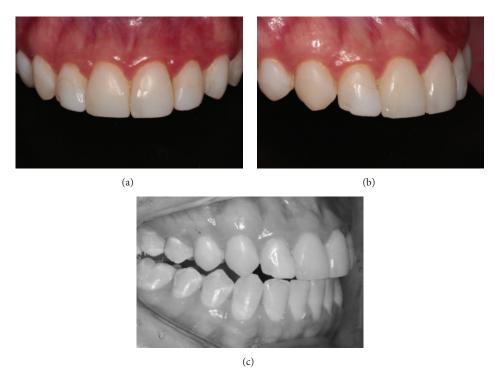
FIGURE 2: Close-up view of frontal (a) and lateral (b) anterior teeth showing worn and stained composite resins. (c) Image of right disclusion showing contact of canine as well as lateral and central incisors.

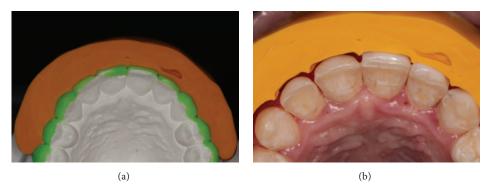
FIGURE 5: Wear guide made with addition of silicone over wax (a) and on teeth (b) during wear of composite resins to assess thickness of the restoration material.

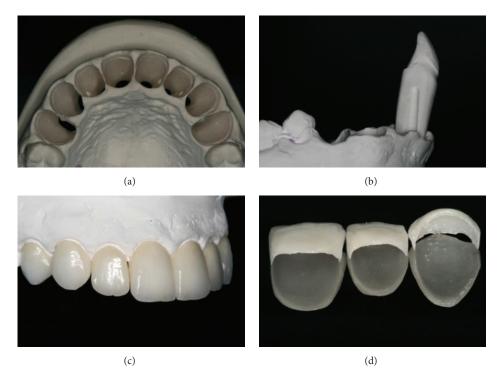
$FIGURE\ 7: (a)-(d)\ Model\ with\ die\ in\ position\ for\ creation\ and\ ceramic\ finish\ to\ allow\ for\ an\ extremely\ precise\ and\ conservative\ restoration.$
